E1551.07-113-11-R0 ACOUSTICAL PERFORMANCE TEST REPORT ASTM E 90 AND ASTM E 492

REGUPOL AMERICA

Series/Model: 5 mm Regupol Sonus

Specimen Type: Floor/Ceiling Assembly

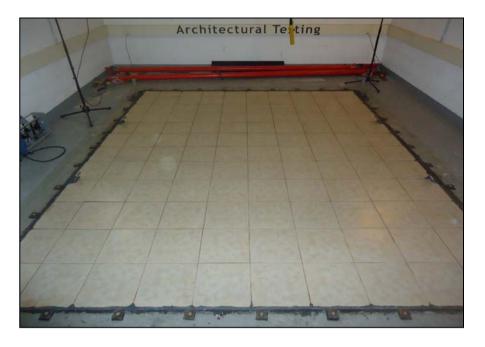
Source Room View of Test Specimen Installation

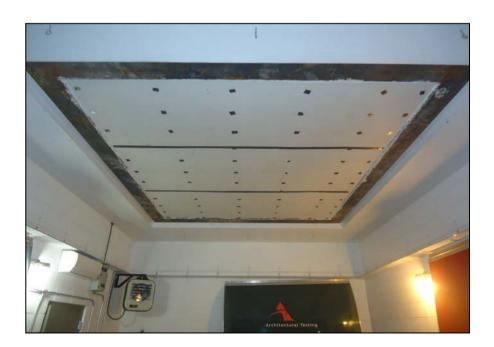
Receive Room View of Test Specimen Installation
