## E1552.06-113-11-R0 ACOUSTICAL PERFORMANCE TEST REPORT ASTM E 90 AND ASTM E 492

Series/Model: 5 mm Regupol Sonus Rubber Underlayment

Specimen Type: Floor/Ceiling Assembly

STC 63 IIC 64

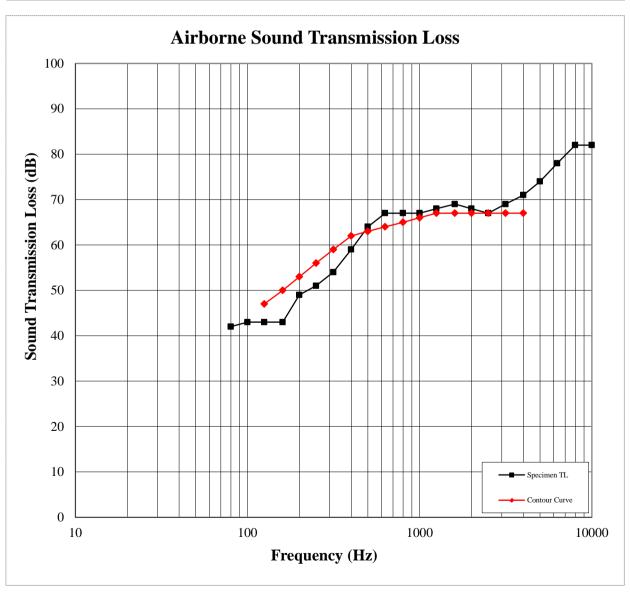
# AIRBORNE SOUND TRANSMISSION LOSS ASTM E 90

STC Rating 63 (Sound Transmission Class)

Test Date	10/28/14
Data File No.	E1552.06
Client	Regupol America
Description	7 mm Ceramic Tile, 5 mm Regupol Sonus Rubber Underlayment, 203 mm Concrete slab, 88.9 mm Johns Manville Kraft-Faced R13 Fiberglass Insulation, 0.5 mm Armstrong HD8906 Drywall Main Beam, 0.5 mm Armstrong XL8945P Cross Tee, 15.88 mm Gold Bond® Fire-Shield® Type X Gypsum Panel
Specimen Area	10.98 m²
Technician	Leeland S. Hoover

Freq	Background	Absorption	Source	Receive	Specimen	95%	Number
2104	SPL	110001 <b>P</b> 01011	SPL	SPL	TL	Confidence	of
(Hz)	(dB)	(m²)	(dB)	(dB)	(dB)	Limit	Deficiencies
80	64.4	14.8	109	66	42	4.80	-
100	49.2	11.5	107	65	43	3.20	-
125	44.3	9.2	107	66	43	2.30	4
160	38.1	8.1	108	68	43	1.70	7
200	31.2	9.7	106	59	49	1.70	4
250	31.8	9.4	106	57	51	1.40	5
315	30.8	8.6	105	53	54	0.90	5
400	27.9	7.0	105	50	59	0.70	3
500	27.5	6.6	106	46	64	1.10	0
630	30.1	6.5	107	43	67	0.50	0
800	30.5	6.7	106	43	67	0.50	0
1000	26.9	6.8	106	42	67	0.50	0
1250	24.7	6.8	106	42	68	0.50	0
1600	21.5	6.8	106	40	69	0.20	0
2000	14.9	7.8	106	41	68	0.40	0
2500	10.9	8.8	105	41	67	0.50	0
3150	9.6	9.5	104	36	69	0.40	0
4000	8.0	11.3	105	34	71	0.50	0
5000	6.2	13.2	104	30	74	0.70	-
6300	6.2	17.2	98	19	78	0.70	-
8000	6.4	23.5	97	13	82	0.80	-
10000	6.4	29.5	92	7	82	0.70	-

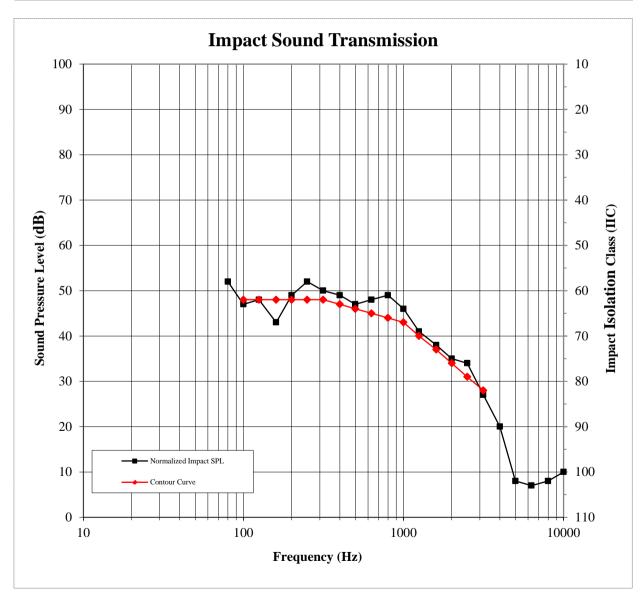
# IMPACT SOUND TRANSMISSION

IIC Rating64(Impact Insulation Class)Deficiencies27(Sum of Deficiencies)

Test Date	10/28/14
Data File No.	E1552.06
Client	Regupol America
Description	7 mm Ceramic Tile, 5 mm Regupol Sonus Rubber Underlayment, 203 mm Concrete slab, 88.9 mm Johns Manville Kraft-Faced R13 Fiberglass Insulation, 0.5 mm Armstrong HD8906 Drywall Main Beam, 0.5 mm Armstrong XL8945P Cross Tee, 15.88 mm Gold Bond® Fire-Shield® Type X Gypsum Panel
Specimen Area	10.98 m²
Technician	Leeland S. Hoover

Ewas	Doolsonound CDI	Absorption	<b>Normalized Impact</b>	95%	Number
Freq	Background SPL	Absorption	SPL	Confidence	of
(Hz)	(dB)	$(m^2)$	(dB)	Limit	Deficiencies
80	63.7	16.4	52	10.7	-
100	49.3	9.7	47	2.4	0
125	45.1	9.5	48	6.8	0
160	37.9	8.6	43	1.5	0
200	31.6	10.6	49	5.2	1
250	30.8	9.6	52	1.1	4
315	30.6	9.0	50	6.4	2
400	27.8	7.5	49	3.2	2
500	26.5	7.0	47	1.1	1
630	29.1	7.1	48	2.8	3
800	29.7	7.2	49	0.9	5
1000	24.4	7.1	46	0.6	3
1250	24.4	7.2	41	3.1	1
1600	20.5	7.4	38	1.3	1
2000	13.8	8.3	35	1.8	1
2500	9.8	9.4	34	1.3	3
3150	8.1	10.3	27	2.3	0
4000	7.4	12.1	20	1.7	-
5000	6.3	14.3	8	0.8	-
6300	6.5	18.5	7	0.3	-
8000	6.7	25.1	8	0.3	-
10000	6.8	32.5	10	0.4	-

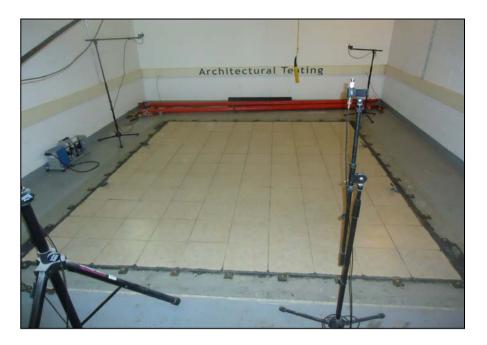
**Source Room View of Test Specimen Installation**

The total weight of the floor/ceiling assembly was 5704.2 kg. Architectural Testing will store samples of the test specimen for four years. Photographs of the test specimen are included in the attachments. A drawing of the test specimen is included in the attachments.

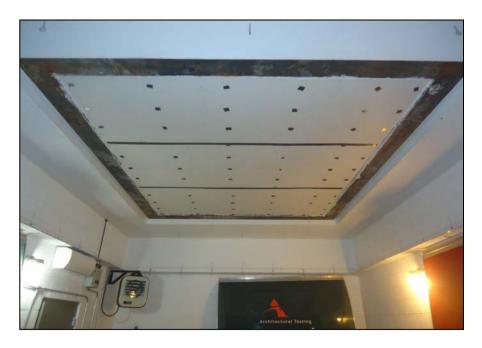
**Receive Room View of Test Specimen Installation**
