E1552.07-113-11-R0
ACOUSTICAL PERFORMANCE TEST REPORT
ASTM E 90 AND ASTM E 492

REGUPOL AMERICA

Series/Model: 12 mm Regupol Sonus Rubber Underlayment

Specimen Type: Floor/Ceiling Assembly

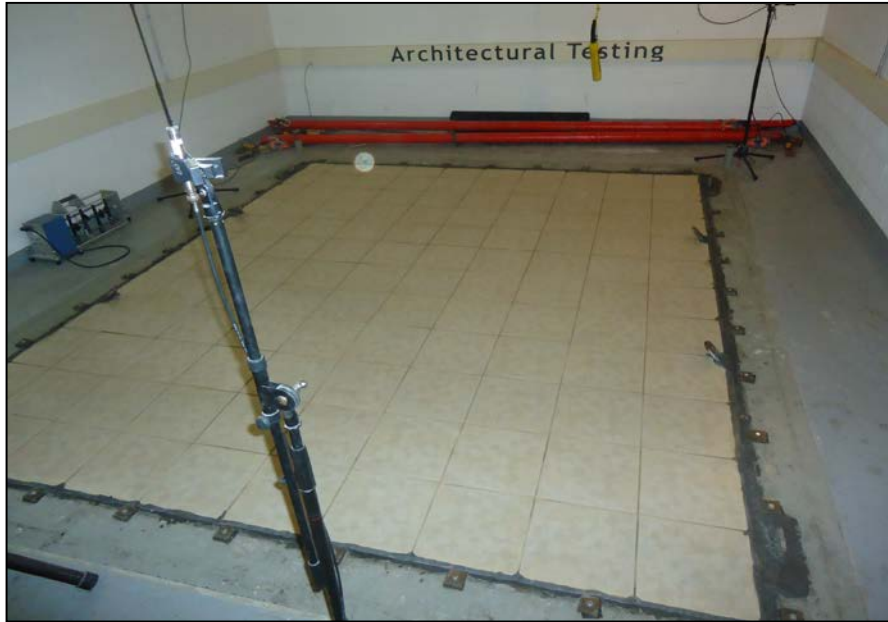
Source Room View of Test Specimen Installation

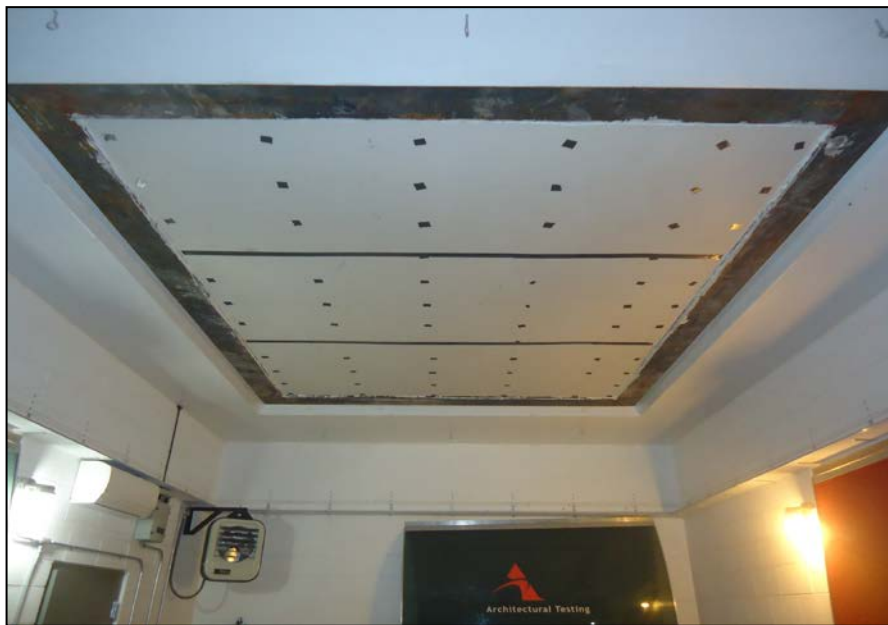
Receive Room View of Test Specimen Installation
